CHARACTERIZATION OF MECHANICAL DAMAGE MECHANISMS IN CERAMIC AND POLYMERIC MATRIX COMPOSITE MATERIALS

By
James Lankford, Jr.

TECHNICAL REPORT
ONR Contract No. N00014-92-C-0093
ONR Contract Authority NR 032-553
SwRI Project 06-5035

This report consists of four papers submitted for publication in the journals noted on the title pages. Some of the work represents collaborative effort between researchers at Southwest Research Institute, Michigan Technical University, and the Commission of the European Communities Joint Research Centre, Ispra, Italy.

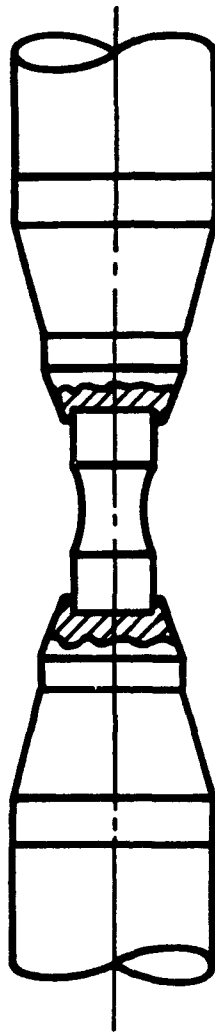
FIGURE 1. Schematic of confined pressure test setup.

Cylindrical specimens 1.2 cm long x 0.6 cm diameter, with a slightly reduced midsection (Figure 1), were machined from sample blanks and their ends ground parallel to within 2 μ m tolerance. Earlier work¹⁸ has verified that this specimen configuration produces compressive strengths equal to or greater than those obtained using standard tabbed panel configurations;

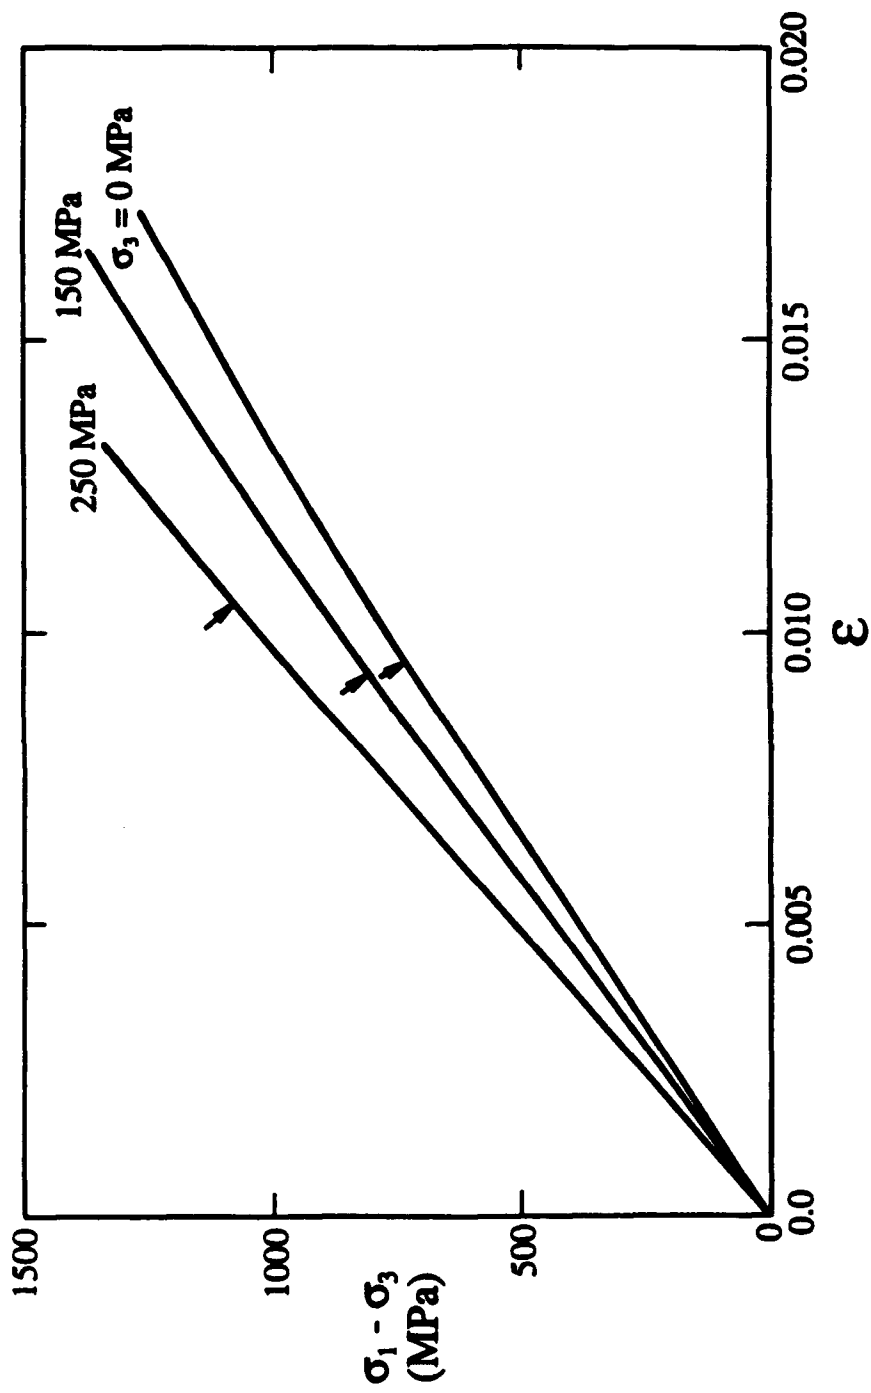
FIGURE 2. Compressive stress-strain behavior of 0° graphite/PEEK for various confining pressures; arrows indicate linear elastic yield point.

Typical stress*-strain curves as a function of pressure for the graphite/PEEK composite are shown in Figure 2. The effect of confinement is to engender an increase in modulus and yield strength, while failure is catastrophic. Efforts to stop a test at the point of instability, by slowing the rate of loading and monitoring acoustic emission, proved ineffectual.

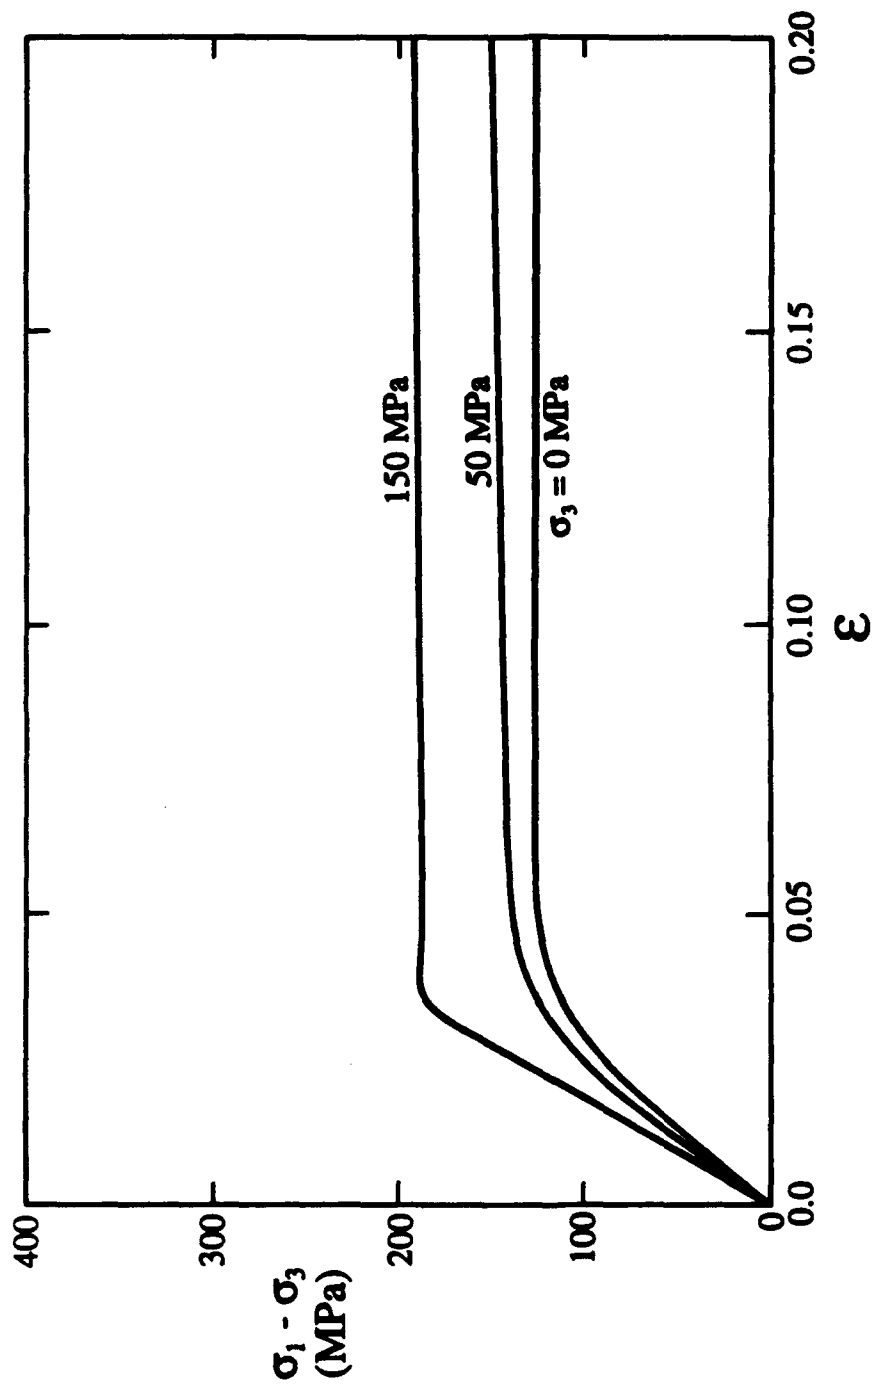
FIGURE 3. Compressive true stress-true strain behavior of PEEK for various confining pressures.

The neat resin itself, on the other hand, exhibits extensive plastic flow following yielding (Figure 3). Pressure raises the yield point (deviation from linear stress-strain relationship), the modulus, and the flow stress. It is notable that reversible strains as high as 5% are reached prior to the onset of true plastic flow, thanks to the low intrinsic modulus of the polymers.

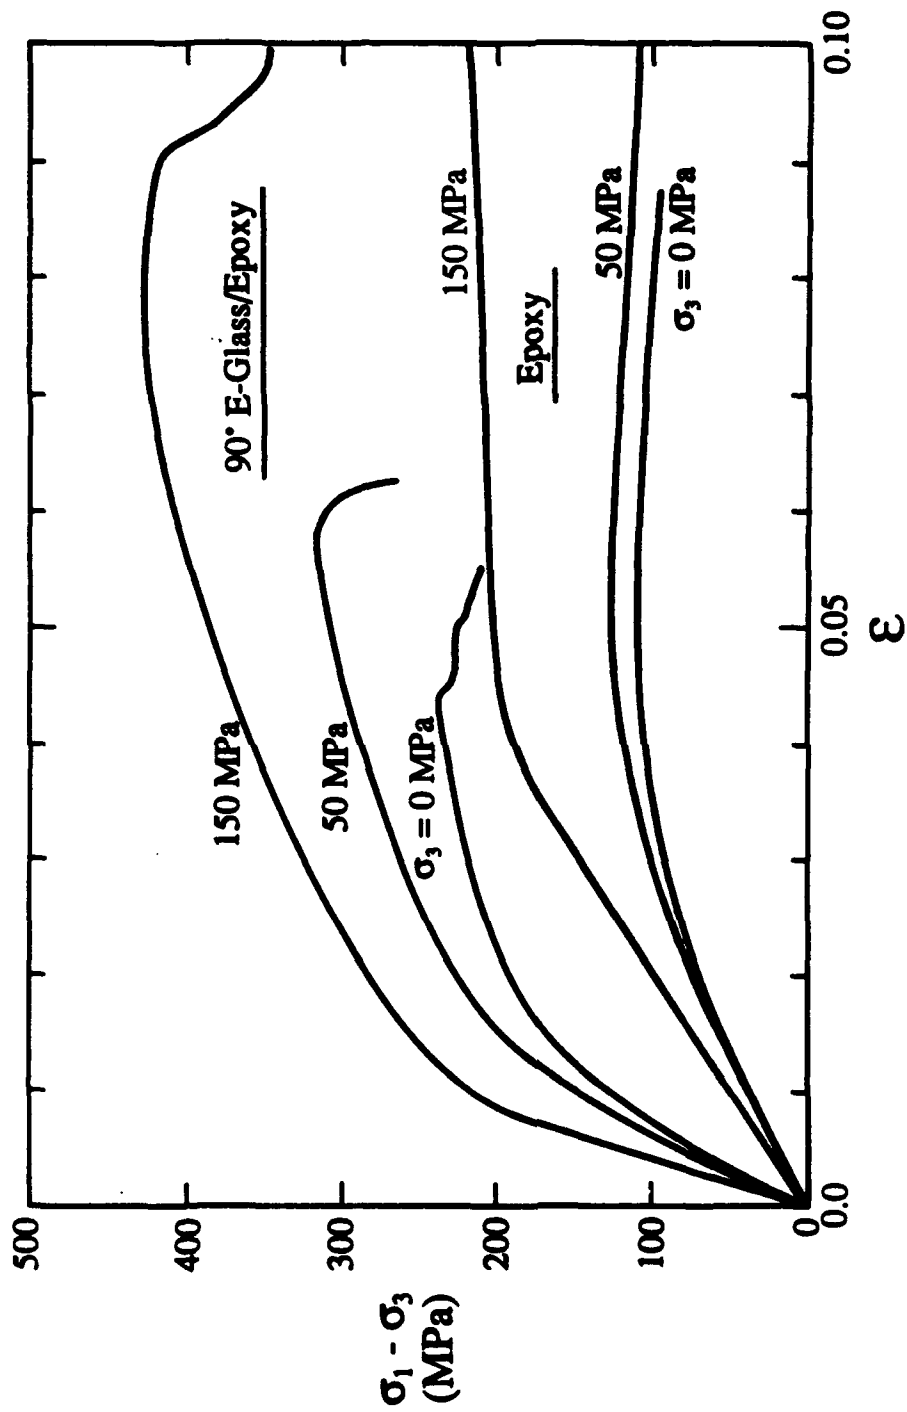
FIGURE 4. Compressive stress-strain behavior of 90° E-glass/epoxy and neat epoxy for various confining pressures.

Deformation behavior of the 0° E-glass/epoxy and the 0°/90° E-glass/PEEK closely resembles that of the 0° graphite/PEEK. Deformation of 90° E-glass/epoxy, however, is intermediate to these general cases, as shown in Figure 4; here strength, modulus, and ductility rise with increasing pressure. For the neat resin, the average flow stress and modulus also rise with pressure, as shown in the same figure. The composite, however, hardens monotonically to its ultimate strength, and then unloads stably before failing catastrophically.

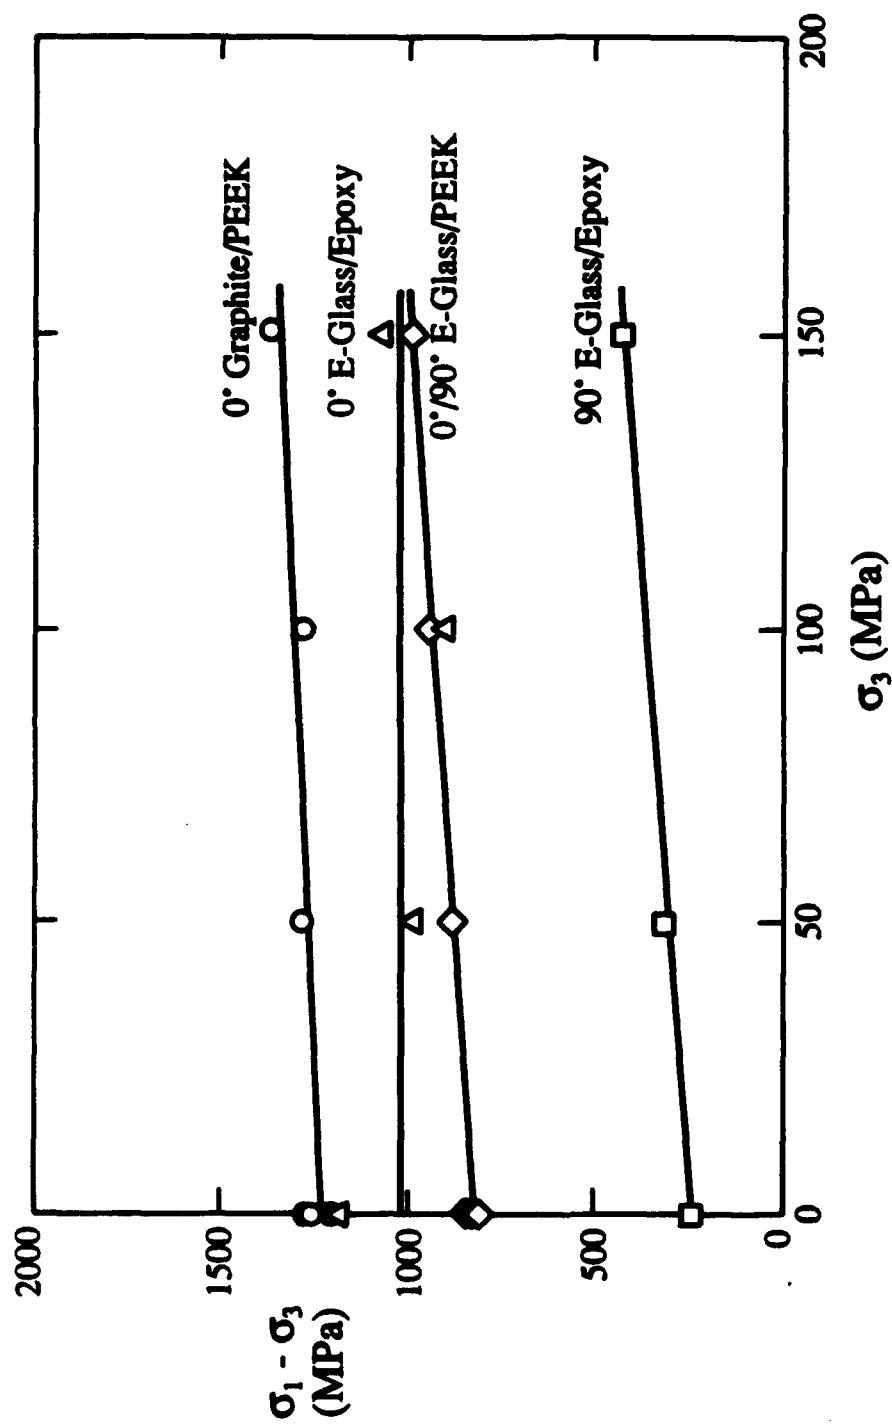
FIGURE 5. Compressive strength versus confining pressure for composite variants.

For all the composite variants, the effect of pressure on strength is moderate, as shown in Figure 5. In particular, there is no functional transition between zero confinement and the application of hydrostatic pressure, suggesting that the key mechanisms responsible for damage development are not altered qualitatively by the relative degree of confinement. In the case of the matrix materials, failure does not occur. Therefore, plotted in Figure 6 are families of curves representing the pressure dependence of the flow stress. It should be noted that large matrix strains (as high as 0.05) of an inelastic nature can occur prior to the onset of plastic flow. This is a consequence of the low "elastic" moduli of the matrices, which are just as pressure sensitive (Figure 7) as the flow stress itself.

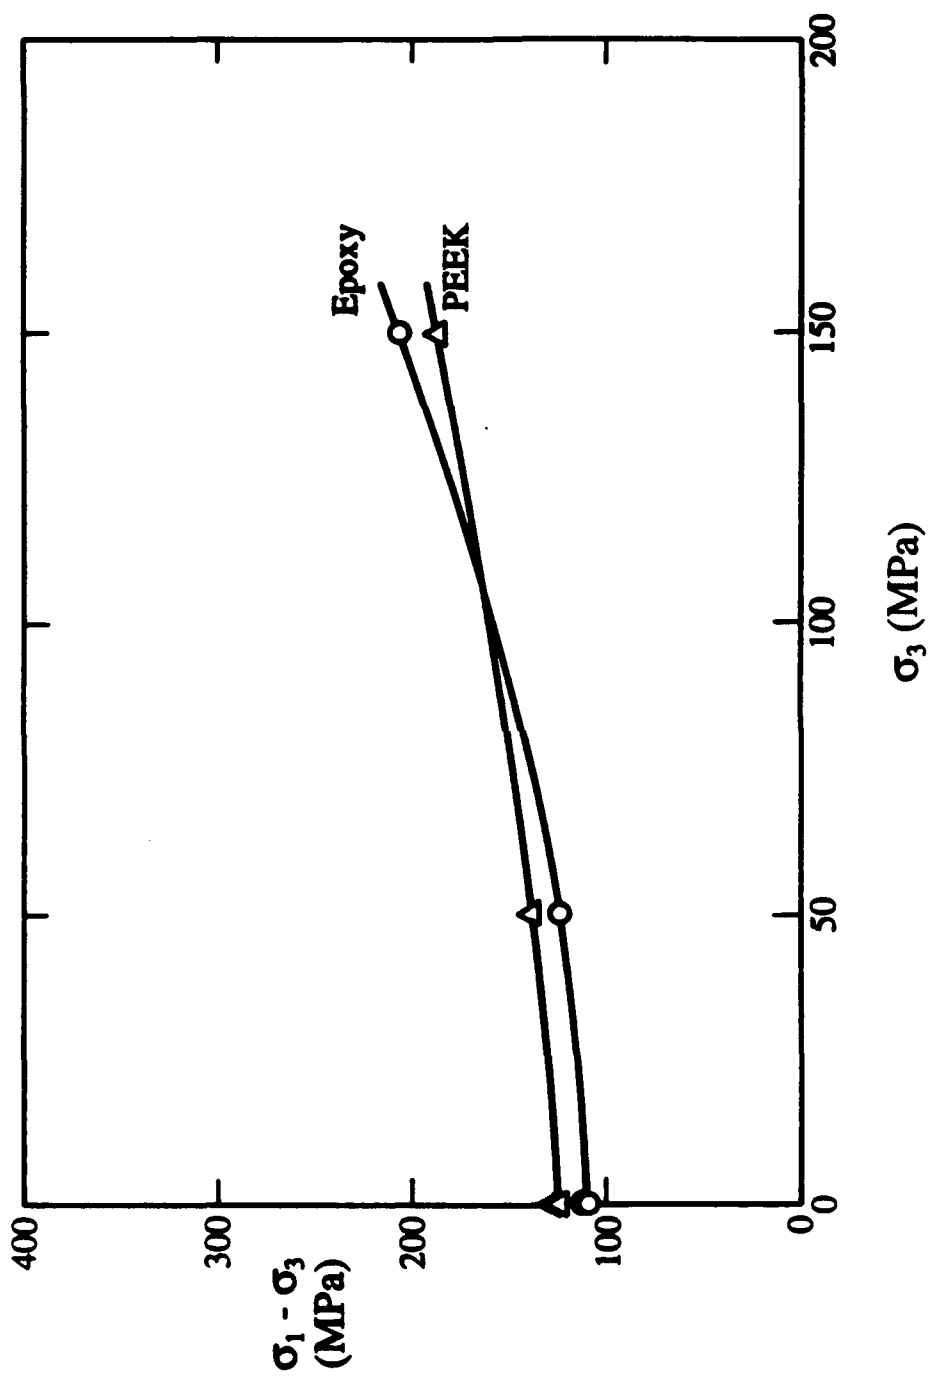
FIGURE 6. Flow stress versus confining pressure for matrix materials.

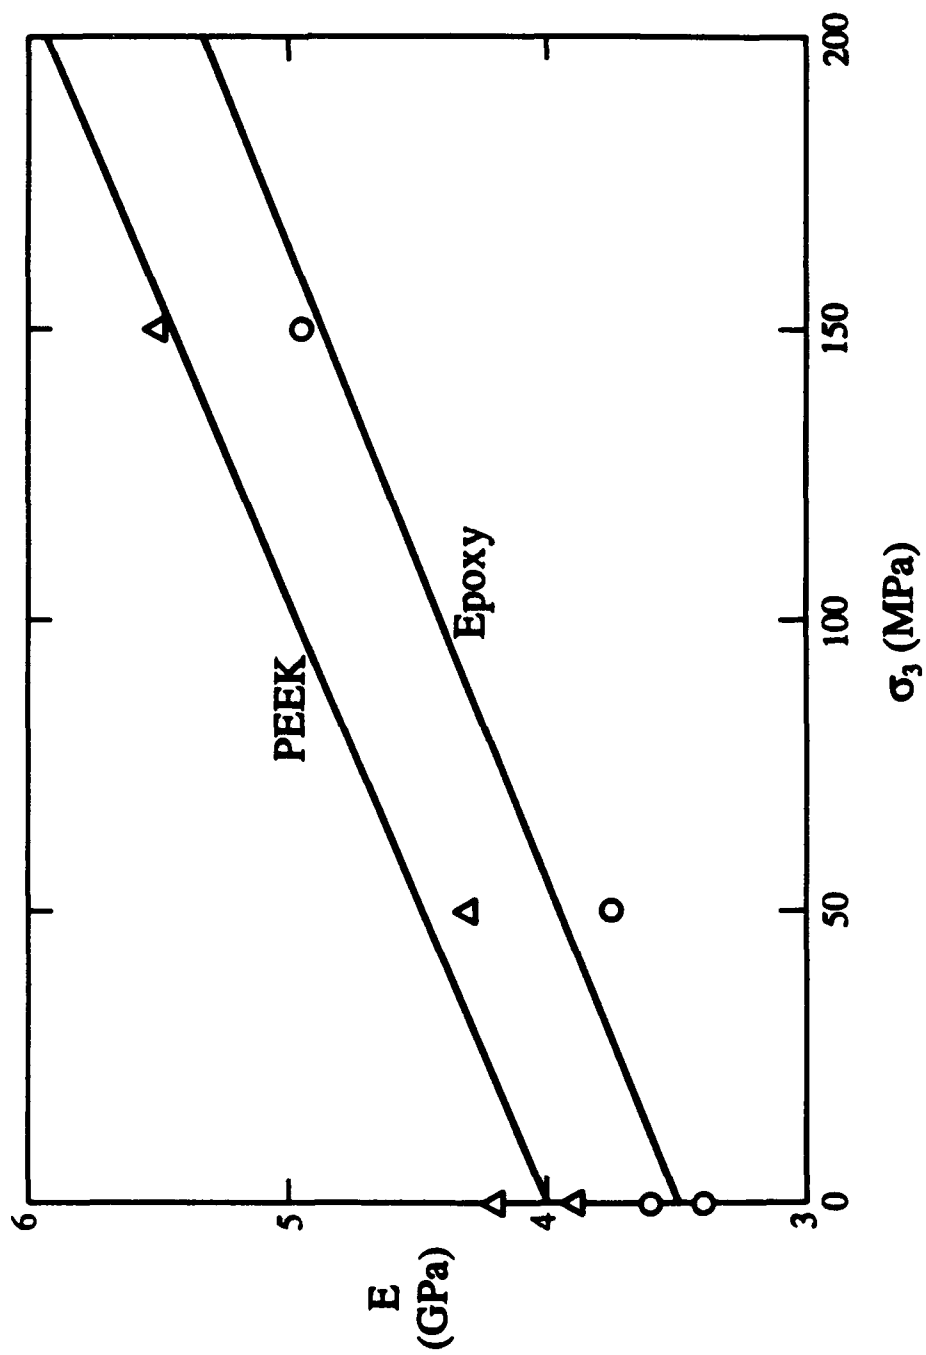
FIGURE 7. Initial elastic modulus versus confining pressure for matrix materials.

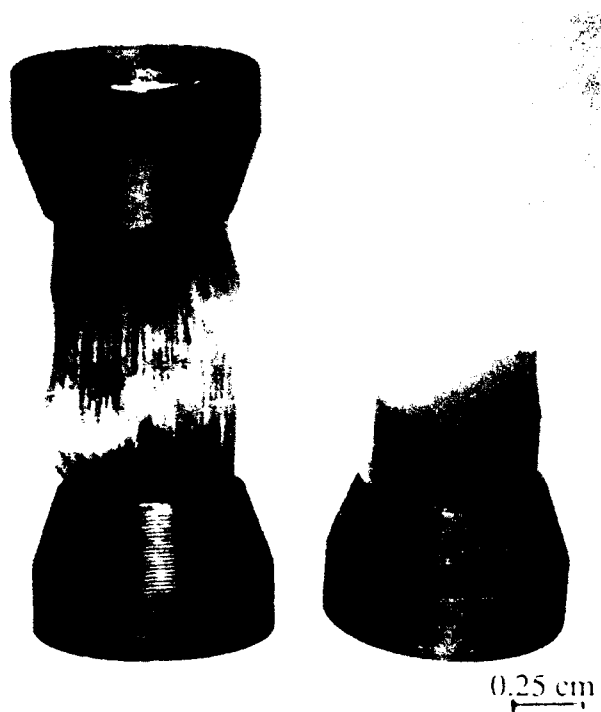
(b) 0° graphite/PEEK, $\sigma_1 = 50$ MPa

(a) 0°/90° E-glass/PEEK

(c) 0° E-glass/epoxy, $\sigma_1 = 150$ MPa

(d) 90° E-glass/epoxy, $\sigma_1 = 150$ MPa

FIGURE 8. Macroscopic composite failure modes.

Failure of the various composites is shown macroscopically in Figure 8. Axial splitting was observed extensively only for the 0°/90° laminate in the unconfined state. Higher pressures totally suppressed this damage mode, while shear failure occurred consistently at about 45° for all levels of confinement including $\sigma_3 = 0$ (Figure 8a). The surface of the shear fault shown in the figure consists of a series of stepped ledges, the risers composed of 0° laminates, and the steps being fractures through the 90° sectors. The other composites failed either by classic kinking (both 0° lay-ups, Figure 8b and c) or 45° shear (90° E-glass/epoxy, Figure 8d). In the case of the former materials, the kink angle for both, relative to the stress axis, was approximately 25°, irrespective of confinement. For the 0° lay-ups, failure was confined to the reduced gage sections, while the higher angle shear planes unavoidably extended out of this zone. However, it was possible to stop a few 90° and 0°/90° tests prior to complete failure, and determine absolutely that shear failure actually began within the reduced section, and not at the load transfer interface.

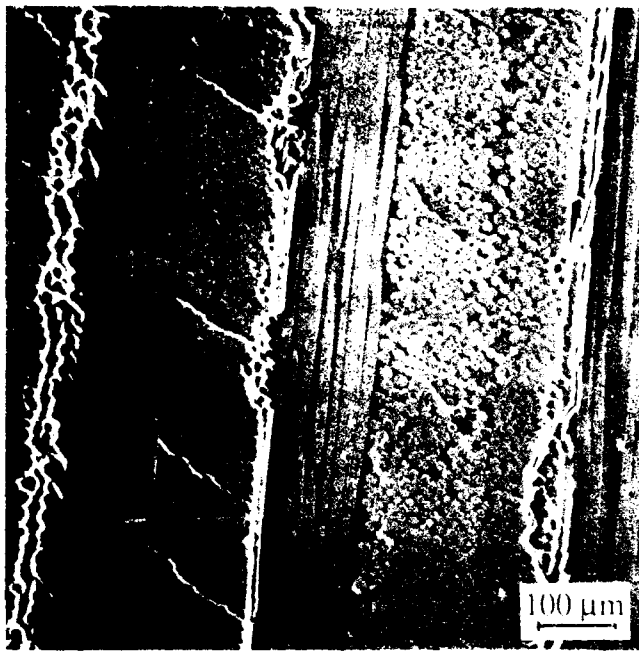
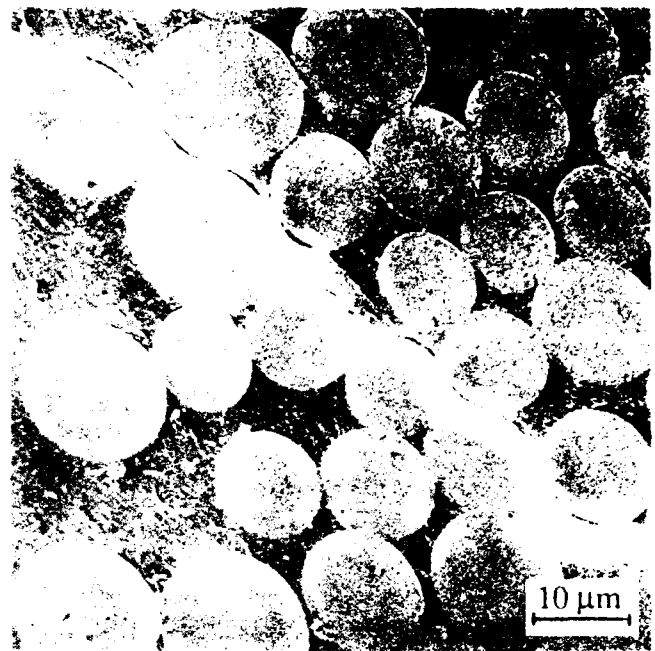
(a) Axial splitting and shear microfracture, both within 90° laminates.

(b) Details of isolated microshear band.

(c) Breakdown of fibrillar craze structure at fiber-matrix boundary.

FIGURE 10 Shear damage mechanisms in 0°/90° E-glass/PFEK; $\sigma_1 = 0$, stress axis vertical.

In the 0°/90° configuration, two types of microscale damage are observed, both confined to the 90° laminates. At low hydrostatic pressures, axial splitting occurs (Figure 10a); this is totally inhibited at pressures in excess of a few MPa. At all pressures, large numbers of microshear bands are nucleated throughout the 90° sectors, as shown in Figure 10a. The bands consist of crack

segments centered on 90° fibers (Figure 10b); the segments form by the breakdown of fibrillar craze structures nucleated at the fiber-matrix interface (Figure 10c). It is evident that the axial lay-ups constitute the ultimate barriers to the growth of the bands (Figure 10a), and that their failure must constitute the final link in the chain of events controlling the life of the specimen. At higher pressures, the 90° shear cracks occur at the same locations (fiber-matrix interface) and at about the same angle relative to the stress axis (Figure 11a). Despite the fact that the microcracks appear somewhat more tightly closed, they still form via craze dilatation and breakdown (Figure 11b), and their ultimate effect is indeed to cause certain 0° sectors to fail by micro-kinking (Figure 11c).

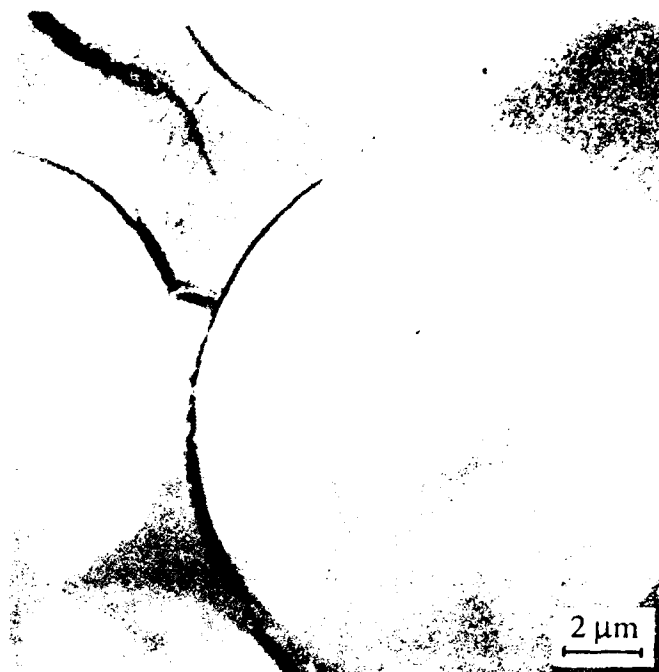
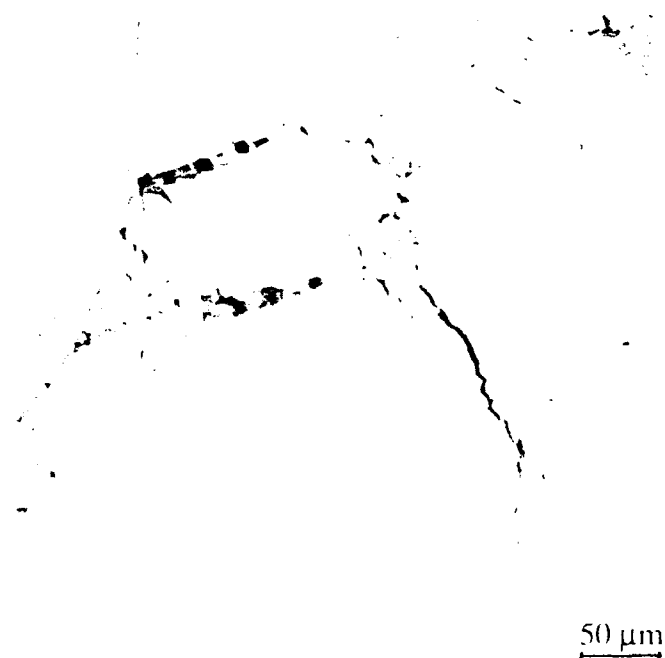
(a) Shear craze-cracks in 90° lay-up.

(b) Details of craze breakdown.

(c) Failure of 0° elements by 90° shear band cracks.

FIGURE 1. Shear damage development in 0°/90° E-glass/PEEK at $\sigma = 150$ MPa, stress axis vertical.

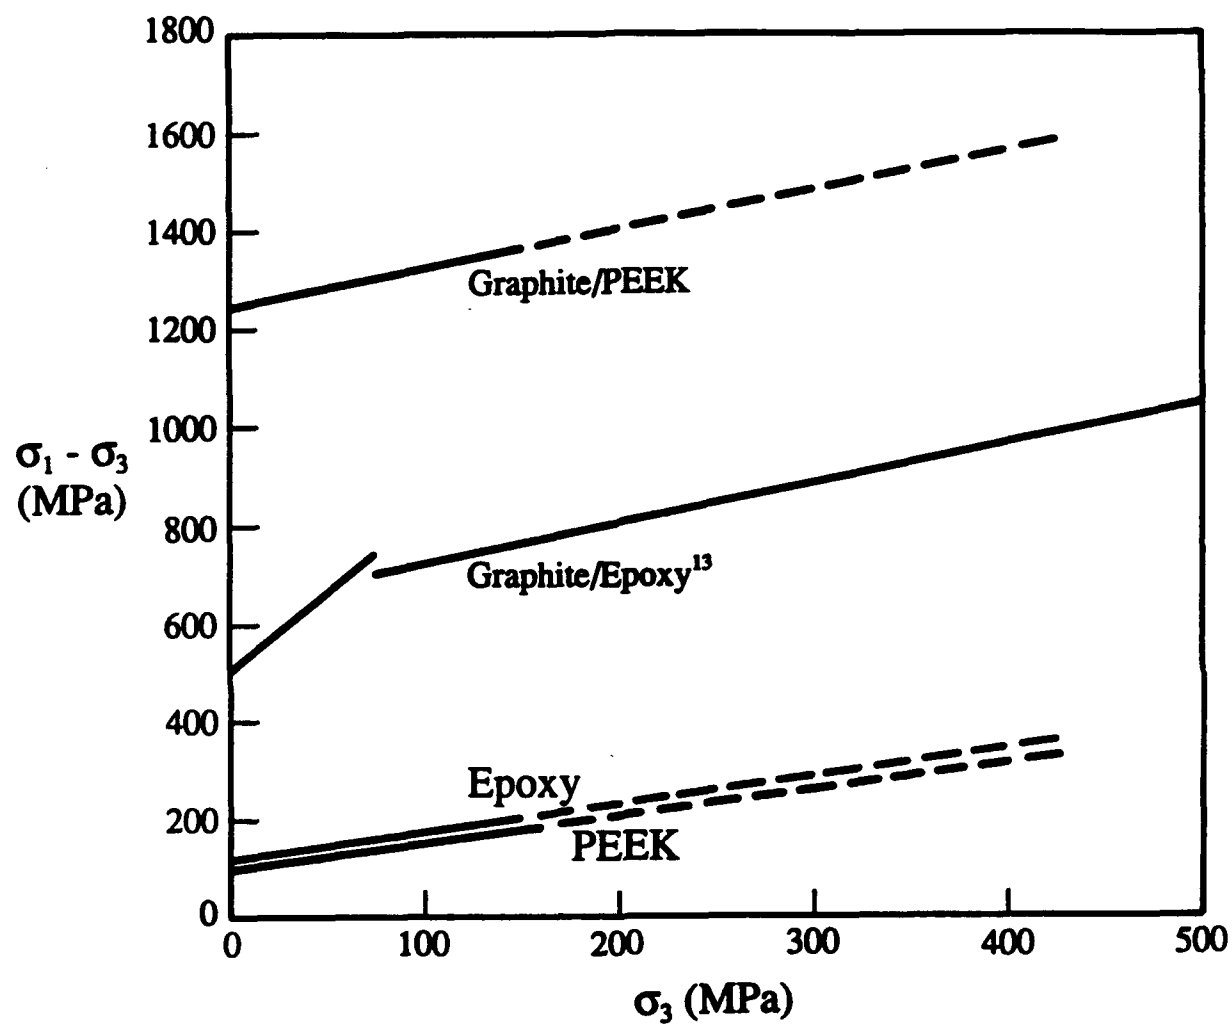
FIGURE 13. Pressure dependence of failure strength for uniaxially-reinforced graphite/PEEK and graphite/epoxy,¹³ compared with pressure dependence of flow stress for pure polymer matrices.

Thus, an initial conclusion is that the true pressure dependence for compressive failure of polymeric composites is mild, and in fact appears to reflect quite directly the pressure dependence measured for the flow stress of the matrix itself (Figure 13). That is, over a given pressure range, the increase in matrix flow stress is reasonably well in accord with the strength decrement affected in the corresponding composites as well, irrespective of lay-up or fiber type. This observation is especially evident for the 0° graphite/PEEK, 0°/90° E-glass/PEEK, and 90° E-glass/epoxy data.

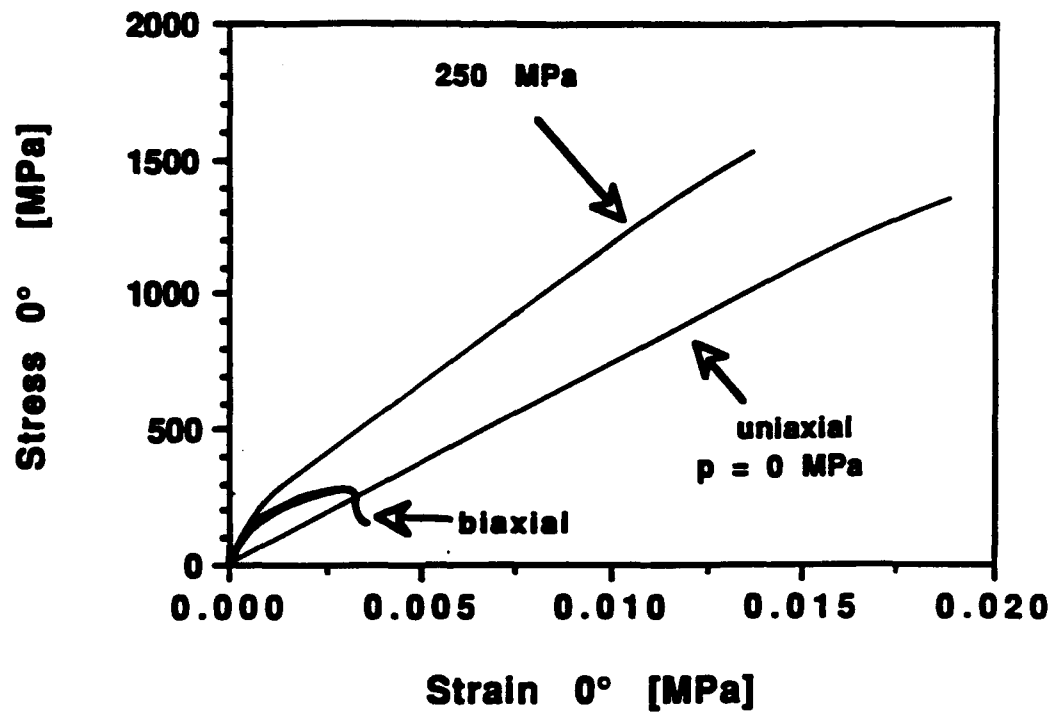
FIGURE 2. Engineering stress-strain response in the fiber direction for uniaxial and biaxial experiments.

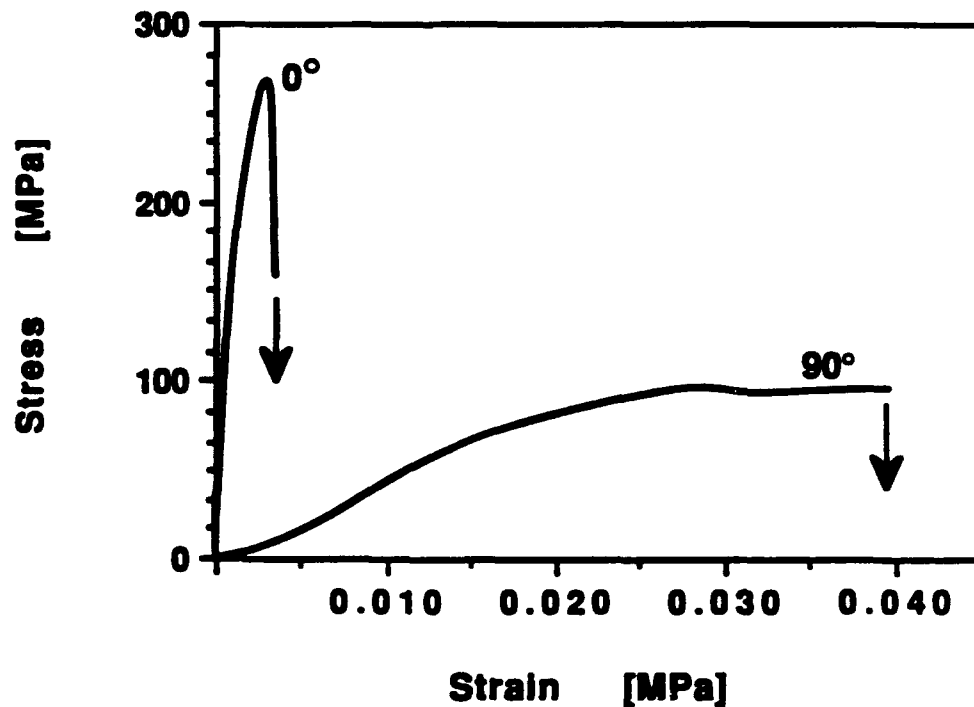
FIGURE 3. Engineering stress-strain response in the two loading directions for the biaxial experiment.

The deformation response of the biaxial specimen within the two loading directions, 0° and 90° , is shown in Figure 3. Large strains are reached in the direction perpendicular to the fibers. In this orientation, the failure strain is about twice that reached in the 0° direction for the pure uniaxial case (Table I and Figure 3).

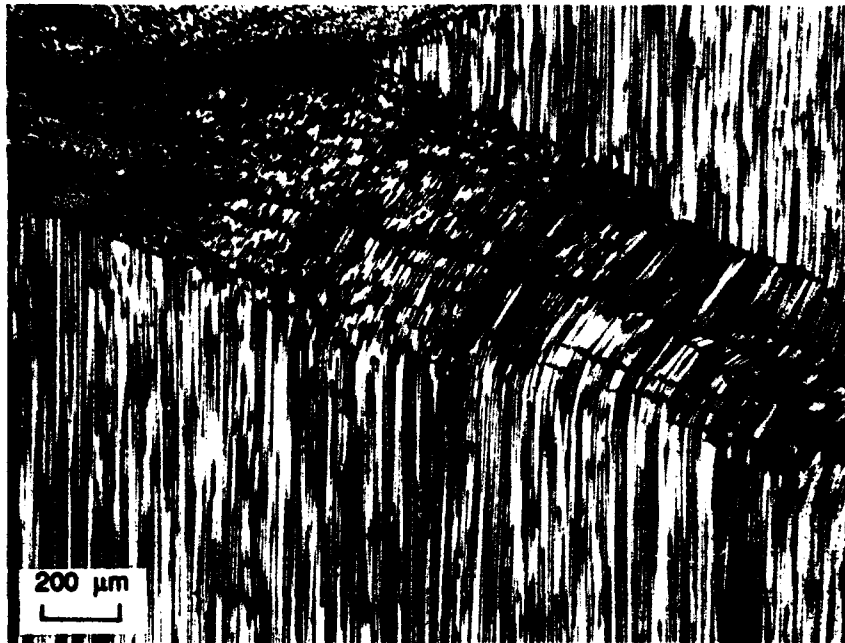
(a) Full section

(b) Detail of the shear band fracture

FIGURE 5. Section of uniaxial specimen tested under ambient pressure.

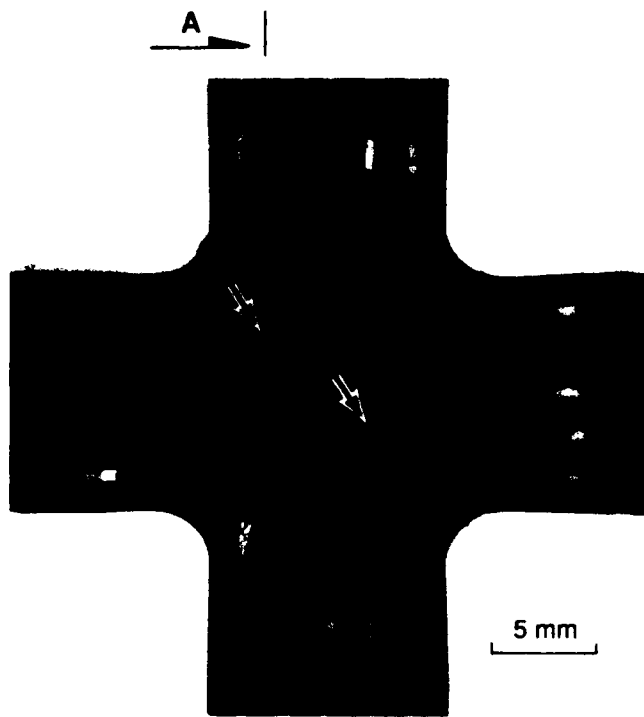
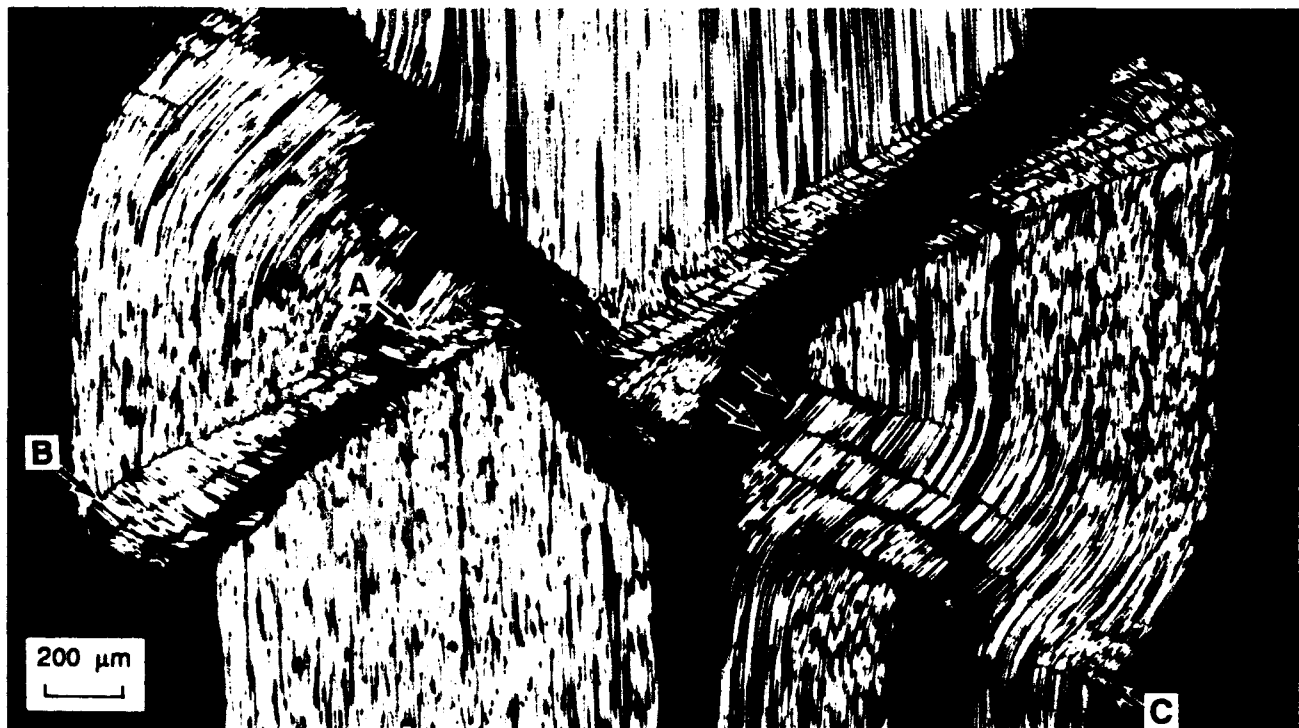
(a) Out of plane view of biaxial specimen, showing two deformation bands of 1 mm width normal to the fiber direction

(b) Photomicrograph of the sectioned specimen (Section AA)

(c) Details of kink/fracture zone in (b).

FIGURE 6. Biaxial damage development.

The most reasonable basis for low stress buckling failure during biaxial compression lies in two synergistic factors: out of plane compliance, and the natural waviness of the fibrous lay-up. Here one does not mean highly local misalignment, such as that alluded to above as responsible for high-strength kinking, but instead the general, volumetric waviness of a group of long fibers. In particular, there is a certain probability that somewhere in the gage section, a number of fibers will share the same wave pattern, *i.e.*, they will be predisposed to buckle out of plane (the so-called shear mode), and to do so at much lower an overall stress level than that required to nucleate an axial kink. Once such an event begins to occur with rising load, the stress in the opposite side of the gage section will rise, and produce an unrestrained gage tendency toward buckling (outward bulging) on that side. A structural instability has now been set up, progressing as shown in

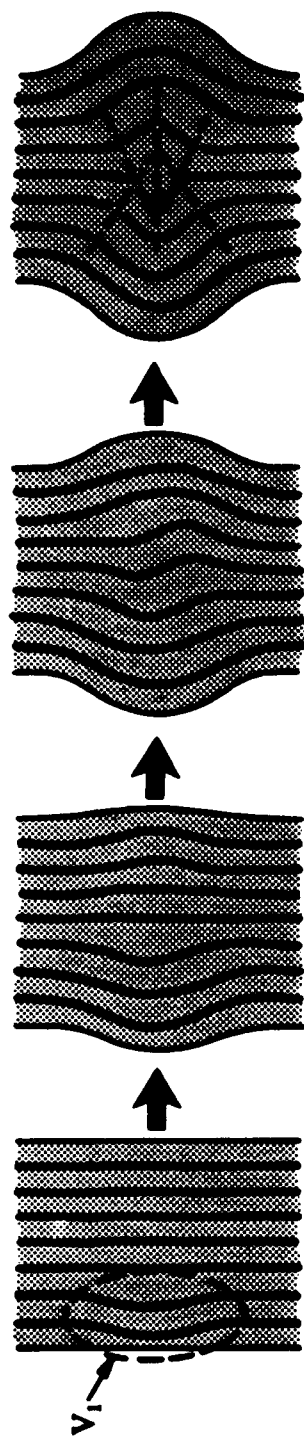
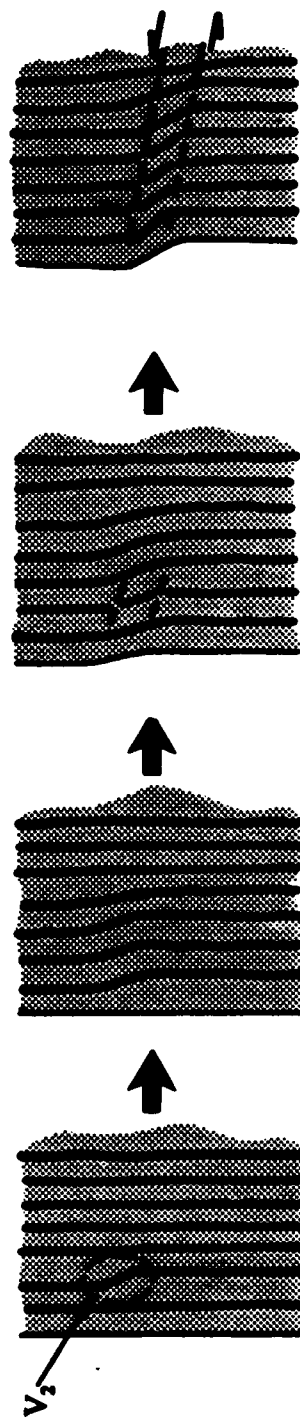
(a) Biaxial sequence; V_1 is volume associated with near surface fibers preferentially aligned for shear mode of microbuckling.

(b) Hydrostatic sequence; V_2 is volume associated with misaligned fiber segment.

FIGURE 7. Schematic of compressive sequence; $V_1 \gg V_2$.

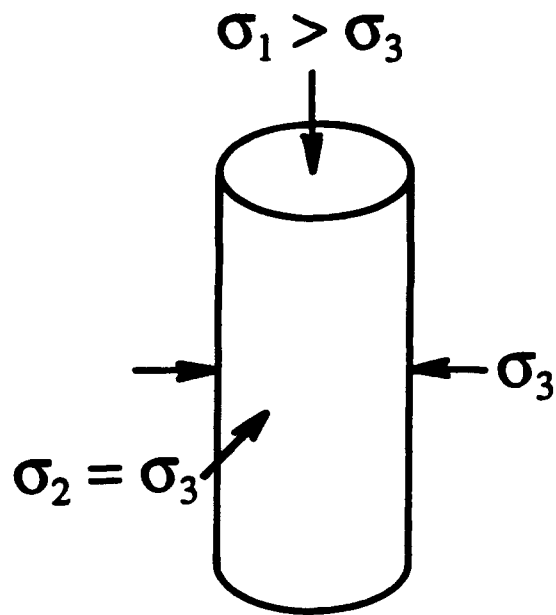
FIGURE 1. Schematic of stress distribution related to combined hydrostatic pressure–compression testing.

where $\sigma_1 - \sigma_3$ is the compressive stress within the material relative to the hydrostat, and θ is the angle which the plane of initial failure makes with the direction of σ_1 . If σ_1 represents the flow or failure stress for various values of σ_3 , the relative influence of shear versus dilatation can be determined by plotting $\sigma_1 - \sigma_3$ versus σ_3 . To the extent that relatively small changes in σ_3 create large increases in $\sigma_1 - \sigma_3$, dilatational crack initiation and/or growth mechanisms probably are involved. Conversely, the absence of pressure sensitivity in $\sigma_1 - \sigma_3$ (*i.e.*, a horizontal plot) would indicate that the strength (flow or failure) is controlled solely by a critical shear stress criterion. For a composite, this critical value is not necessarily⁸ the maximum macroscopic shear stress, as is

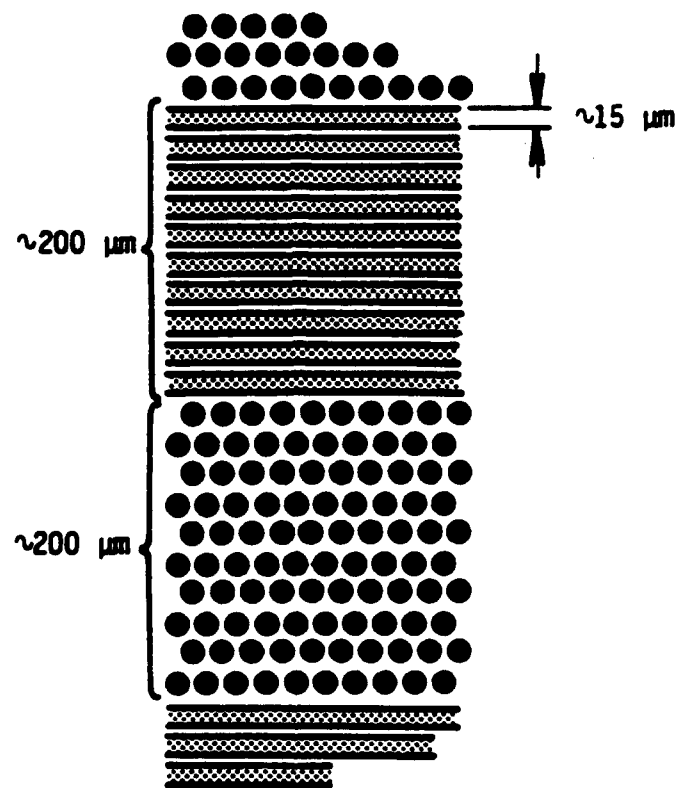
FIGURE 2. Dimensions and orientations of cross-ply bundles and fibers.

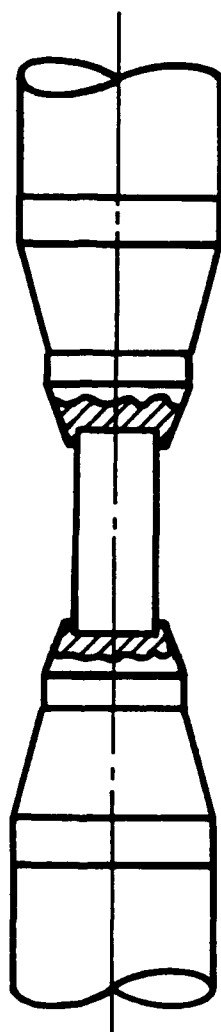
FIGURE 3. Schematic of compression test setup.

Controlled strain rate tests were performed at approximately 10^{-4}s^{-1} and 1s^{-1} , with a servo-controlled hydraulic ram supplying the axial load. For tests with radial confining pressure, a special pressure vessel was utilized. In performing these experiments, the hydrostatic pressure was first raised to the desired level by pumping fluid into the pressure vessel while a servo-controller matched the axial stress to the pressure. The axial load was then increased under displacement control at fixed pressure. A bridge of four electrical resistance strain gages inside the pressure vessel measured the axial load. Since the hydrostatic pressure produced a zero shift in the output of this load cell, the magnitude of the shift was measured in a series of calibration runs and subtracted from the load measurements. Hydrostatic pressure was measured by a diaphragm-type electrical pressure transducer located at the fluid inlet orifice of the pressure vessel. The exact value of the strain rate, $\dot{\epsilon}$, was determined by measuring the stress rate, $\dot{\sigma}$, and calculating $\dot{\epsilon}$ using the appropriate value for Young's modulus, E , for each material, *i.e.*, $\dot{\epsilon} = \dot{\sigma}/E$. All samples were tested at room temperature, under confining pressures as high as 350 MPa.

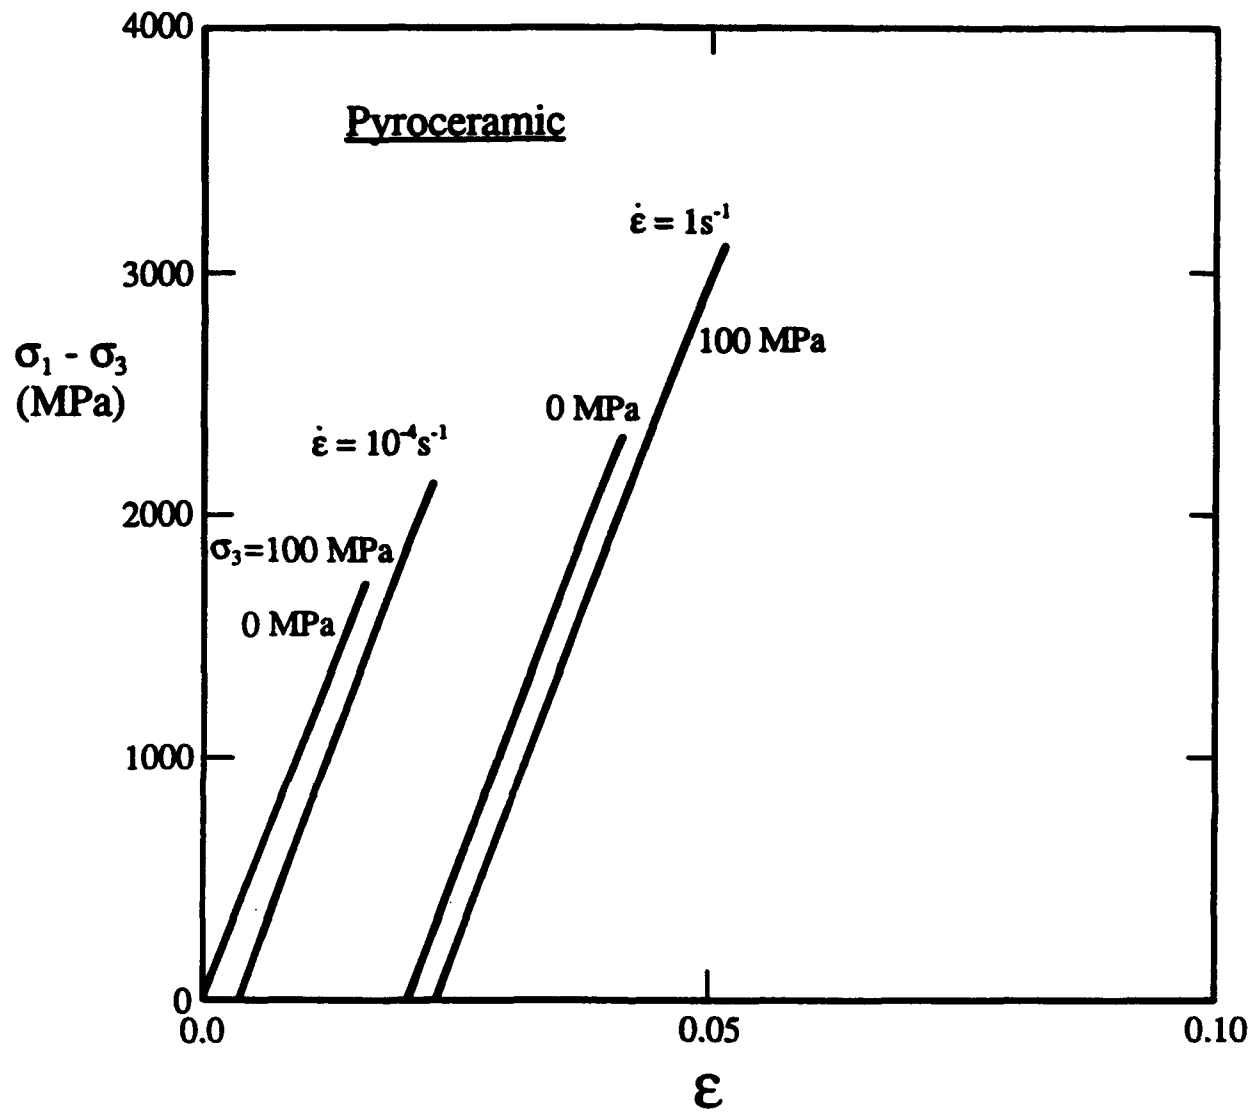
FIGURE 4. Axial stress versus strain for matrix material.

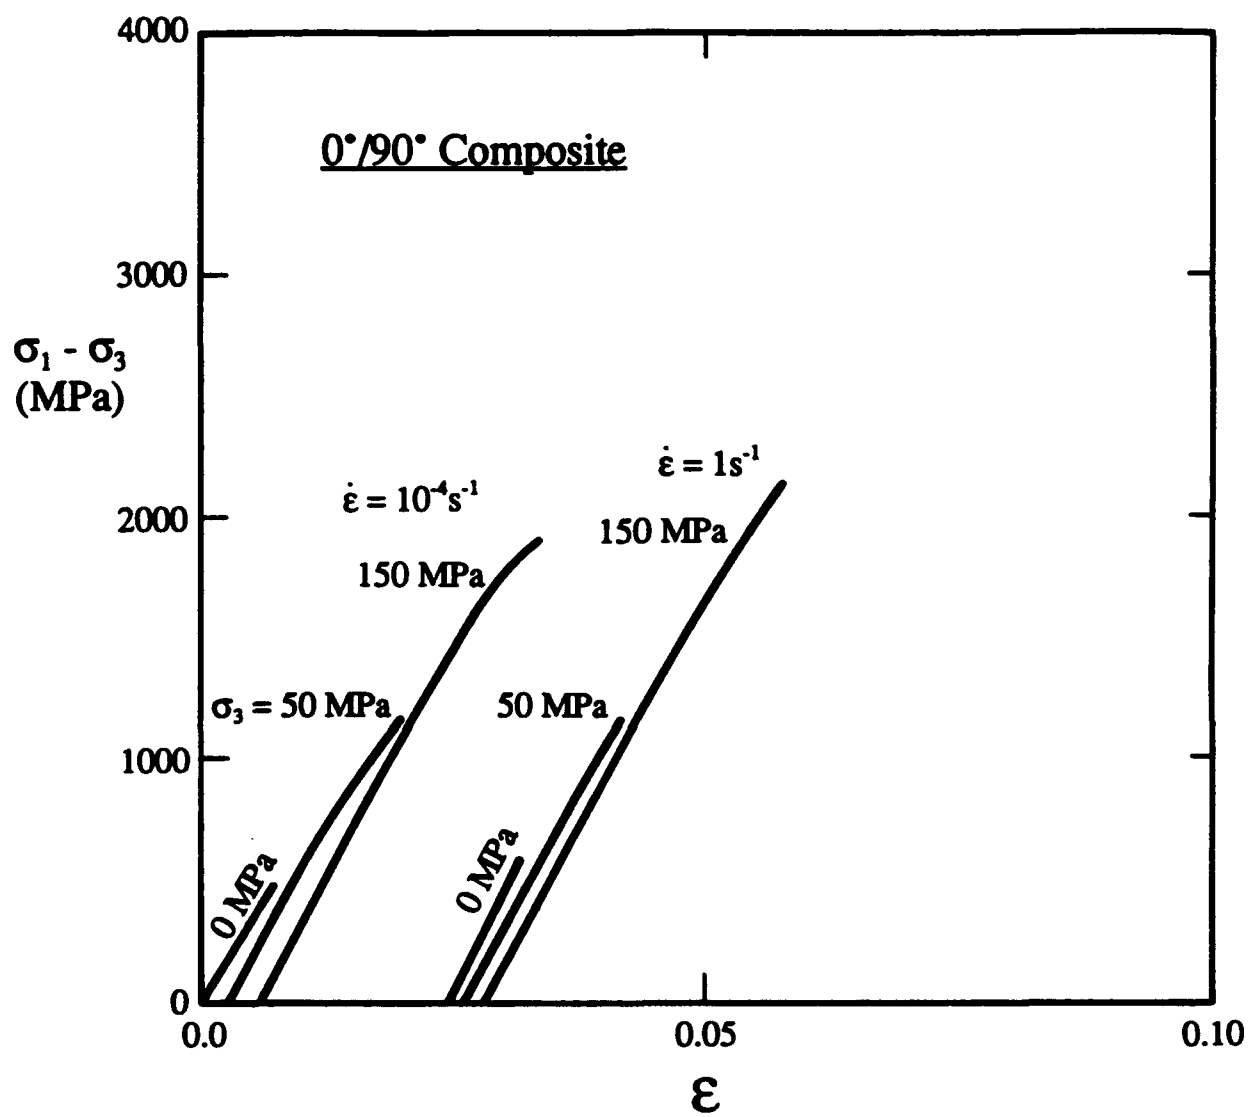
FIGURE 5. Axial stress versus strain for 0°/90° composite.

This simple pattern is not followed by the composites. For 0°/90° reinforcement (Figure 5), linear stress-strain is observed only for the higher strain rate ($\dot{\epsilon} = 1\text{s}^{-1}$), with ultimate strength rising steadily with confinement. Under quasistatic conditions ($\dot{\epsilon} = 10^{-4}\text{s}^{-1}$), "yielding" occurs prior to failure, with "yield" stress, failure strength, and "ductility" all increasing with confining pressure. Strength is independent of strain rate.
